NACA RM A53G22

RESEARCH MEMORANDUM

CORRELATION OF FLIGHT AND WIND-TUNNEL MEASUREMENTS OF

ROLL-OFF IN LOW-SPEED STALLS ON A 35°

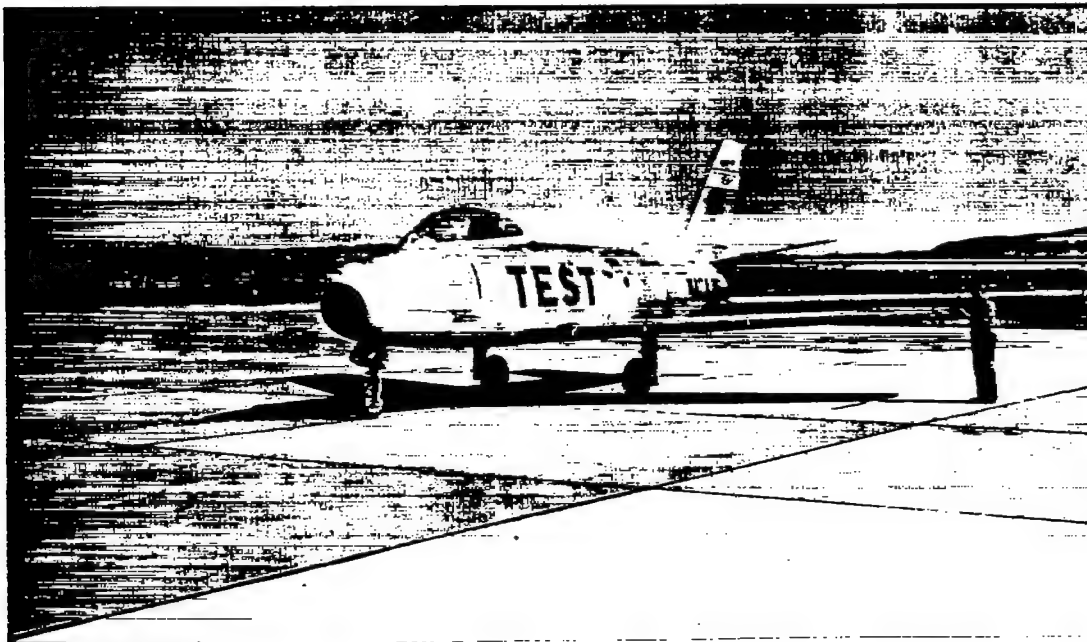
(a) Airplane tested in flight.

(b) Airplane tested in the 40- by 80-foot wind tunnel.

Figure 1.- Photographs of test airplane.

The tests were conducted on a jet-powered fighter aircraft having sweptback wing and tail surfaces. Photographs of similar test airplanes as prepared for flight and wind-tunnel tests are presented in figures 1(a) and 1(b), respectively. Figure 2 is a two-view drawing of the airplane. A description of the geometric details of the airplane is given in table I.
